Manhole Inspection Summary

Manhole # S39G__105MH

Location Address: **866 E Lombard St**

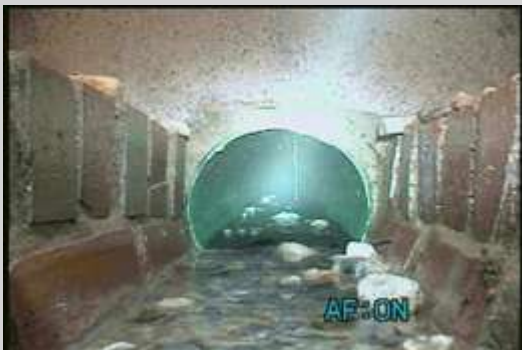
12 O'Clock Outflow

8 in. Circular Gravity Sewer
Pipe Out @ 12 O'Clock

Invert Depth: 11.40 (ft.) Flow Characteristics: Slow

Deposits: ☒ None ☐ Mud ☐ Sludge ☐ Debris ☐ Grease

Infiltration: None Pipe Seal Cond: Unknown

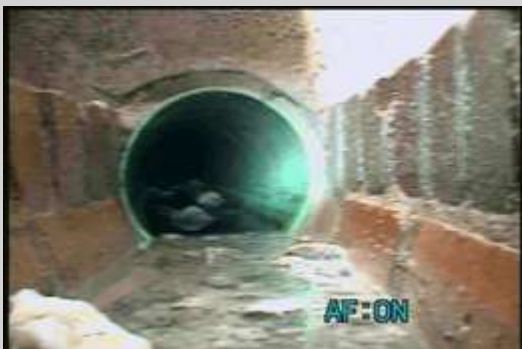
6 O'Clock Inflow

8 in. Circular Gravity Sewer
Pipe In @ 6 O'Clock

Infiltration: None Pipe Seal Cond: Unknown
